Manhole Inspection Summary

Manhole # S15SS1016MH

Insp Date: **6/20/07 3:28 PM**

Location Address: **CYLBURN AVE**

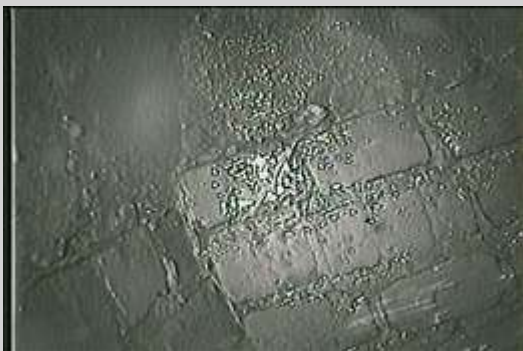
Pipe In @ 6 O'Clock

Pipe Material: ☐ Pipe Lined

Invert Depth: (ft.) Flow Characteristics: **None**

Infiltration: **None** Pipe Seal Cond: **Unknown**
